**Observations of Fish Behavior Recorded by a DIDSON Sonar Concurrent with
Blasting Events During Renovation of the Lyle Falls Fish Ladder**

Galbreath, P. F., S. Keep, J. Zendt and C. R. Frederiksen. 2010. Observations of Fish Behavior Recorded by a DIDSON Sonar Concurrent with Blasting Events During Renovation of the Lyle Falls Fish Ladder. Columbia River Inter-Tribal Fish Commission Technical Report 10-02, Portland, Oregon. (http://maps.critfc.org/tech/10_02report.html)

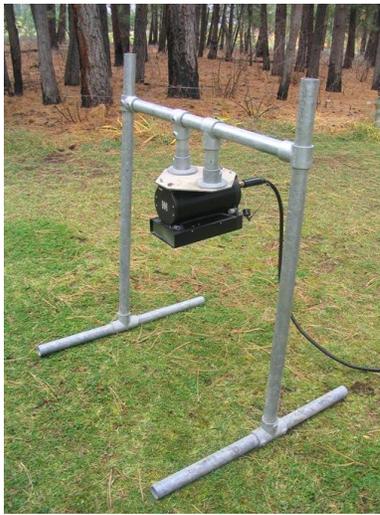
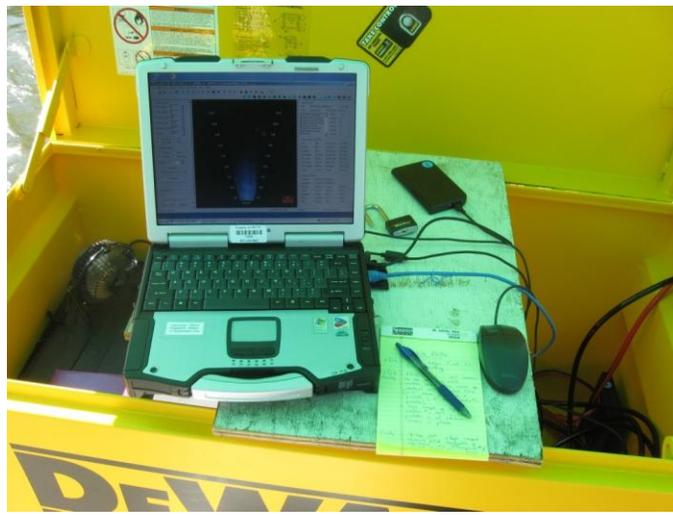
A

B

C

Figure 2. - A) DIDSON on stand. B) Field computer and external hard drive. C) Schematic - top view - of placement of DIDSON within the Lyle Falls Ladder fish trap.

On April 16, 2010, we installed a DIDSON-S (equipped with a spreader lens) within the adult trap in the Lyle Falls fish ladder. The sonar was programmed with a 0.5 m Start Length, a 5 m Window Length, and set to record at 15 frames per second. The sonar was mounted in a downstream corner of the trap on an “H-frame” stand, with the sonar lens approximately 0.8 m above the bottom and directed across towards the opposite upstream corner (Figure 2). The resulting field of view encompassed approximately a third of the water column near the bottom of the trap. The DIDSON was linked to a field computer and a 500 GB external hard drive, both of which were kept in a locked metal job site storage box placed in the vicinity of the trap (Figure 2). While operating, the DIDSON recorded sequential 1-hour files directly to the external hard drive. Power was supplied to the DIDSON and computer with two pairs of 12 v batteries, placed in an adjacent storage box, linked in series to provide the 24 volts DC output required by the sonar. The computer was supplied with 12 volts DC with use of a 24 v to 12 v converter; the hard drive was powered from the computer through the USB cable. The batteries were replaced, one pair at a time, with freshly recharged batteries every couple days of operation. The DIDSON was operated during the following periods within three consecutive work weeks: 4/18 (9 AM) to 4/23 (6 PM), 4/26 (10 AM) to 4/30 (11 AM), and 5/4 (10 AM) to 5/6 (2 AM).
